APA REPORT ON SKANDATUT SITE VISIT
AUGUST 03, 2011 TO ASSESS SITE PROTECTION
WITH OBSERVERS FROM THE WILLIAMS TREATIES

Abandoned and Neglected – The Skandatut Village, 2010-2011

Current Site Condition (10 months after Stop Work Order)

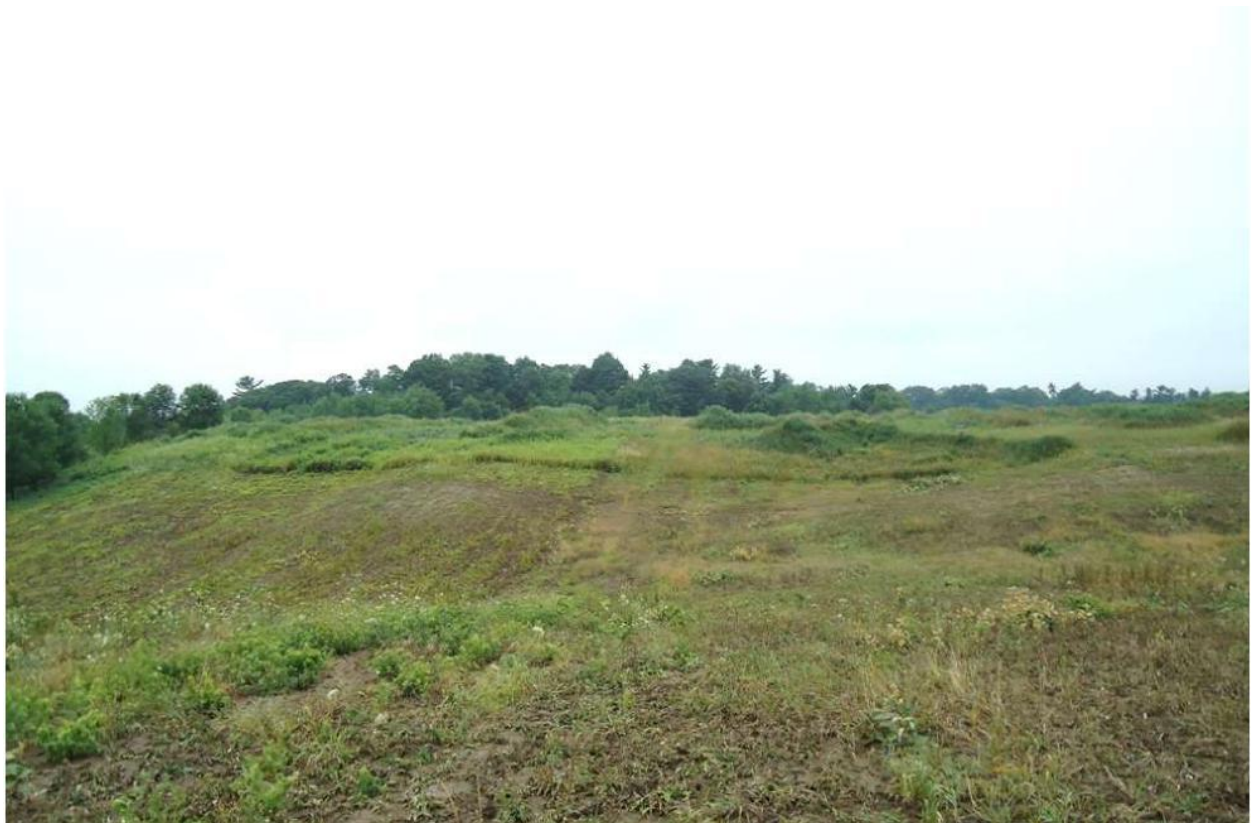
Photo 1 - View to West of Skandatut Village on Plateau in Rear of Photo (Note: Weeds are Cropped Up to the Edge of the Site, Large Grassy Mounds are Topsoil Stockpiles). August 03, 2011.

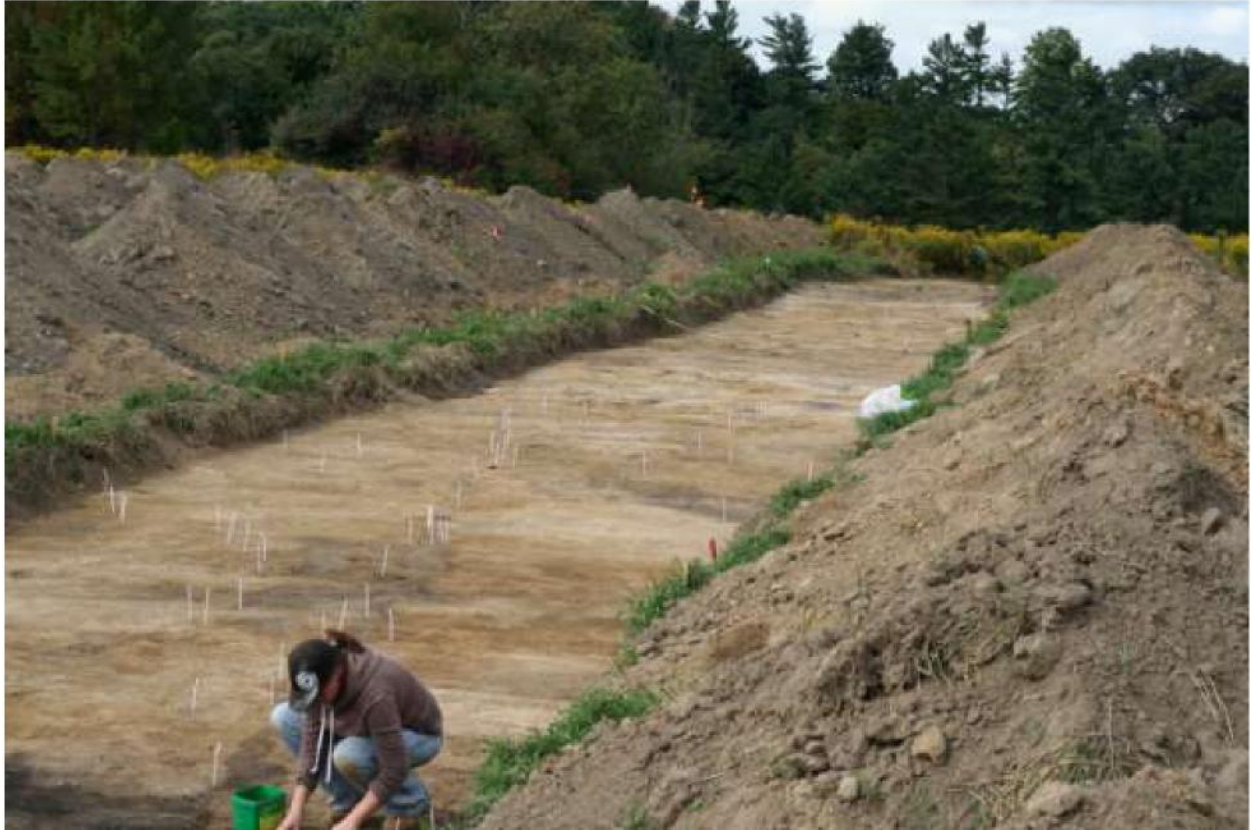
Photo 2 - View to South West of September 2010 Trench Excavation Immediately Prior to MTC Stop Work Order. Photo Courtesy of K. Powers.

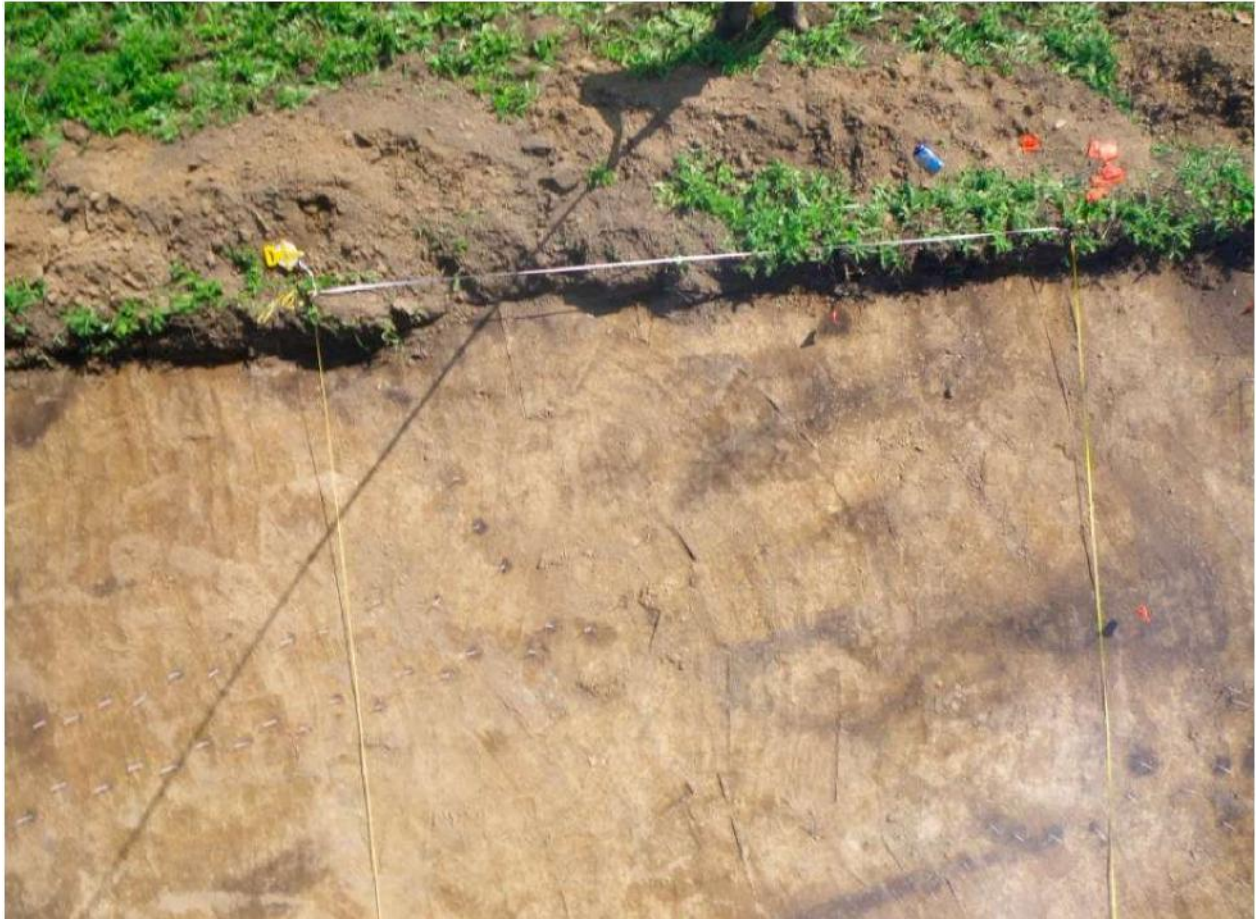
Photo 3 Aerial View of Trench Subsoil Floor, Gridded and Prepared for Recording, September 2010. Photo Courtesy of K. Powers.

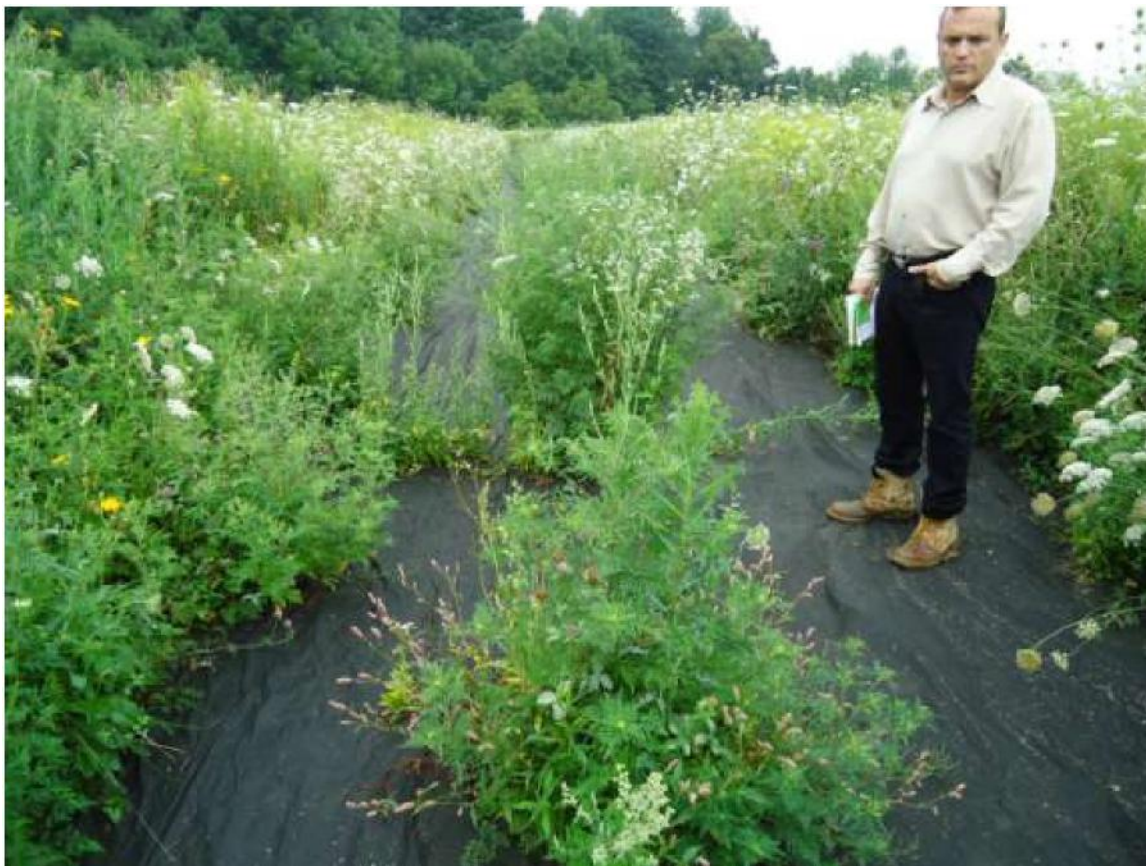
The following observations of site condition focus on the improper installation of geotextile, failure to shore up open trenches, rainfall erosion and damaging weed growth. Every trench covered with geotextile has substantial and obscuring vegetation growth (*see Photo 4*). Geotextile is not effective in areas of subzero winter temperatures unless it is covered by a depth of soil or straw. Based on our observations on August 03, 2011, covering fill had not been placed on any part of the site by MTC staff, either in the fall of 2010 or in May and June of 2011. The ground beneath the geotextile in the exposed trenches is significantly heaved by freeze and thaw action, causing major disturbance to the surface areas of subsoil features and posts, and there is also considerable erosion beneath the geotextile in areas with any slope (*see Photo 5*). The purpose of adding covering soil is not only to reduce frost damage but to discourage vegetation growth underneath and through the geotextile. Throughout the site, vegetation is growing on the geotextile, through the geotextile and under the geotextile. Significant root structures have developed and their removal will result in appreciable damage to subsoil features and posts known to be present directly beneath the geotextile.

Photo 4 . View to Northwest of Overgrown 5 Meter Wide Trench Covered by Geotextile Which is Penetrated by Weed Growth (Joe Pandolfo looks on). August 03, 2011.

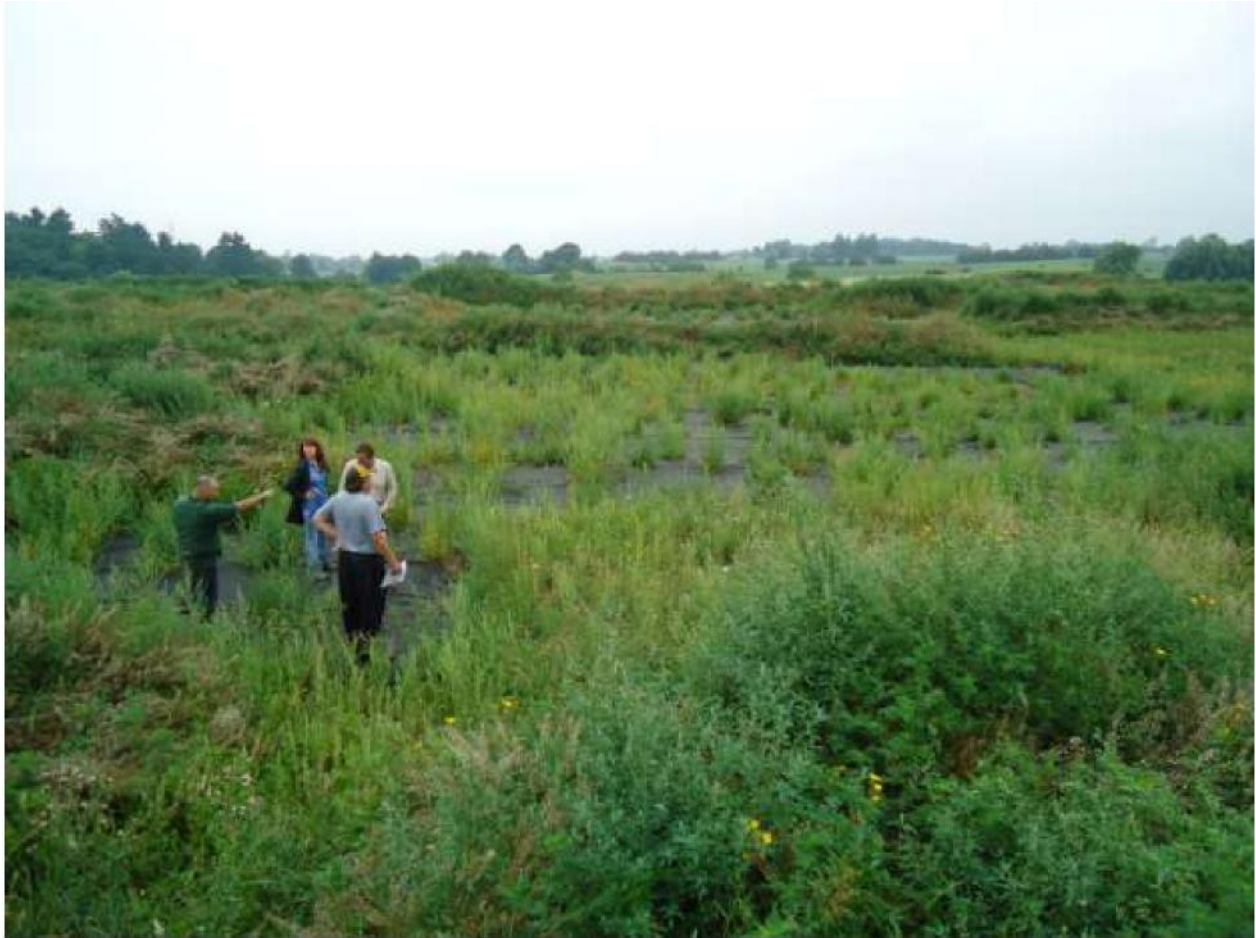
Photo 5: View to Northwest of Palisade Excavation Area Completely Overgrown (Note: Excavation Area is About Two-Thirds the Width of the Picture, Geotextile Can Be Seen in Clear Patches) August 03, 2011.

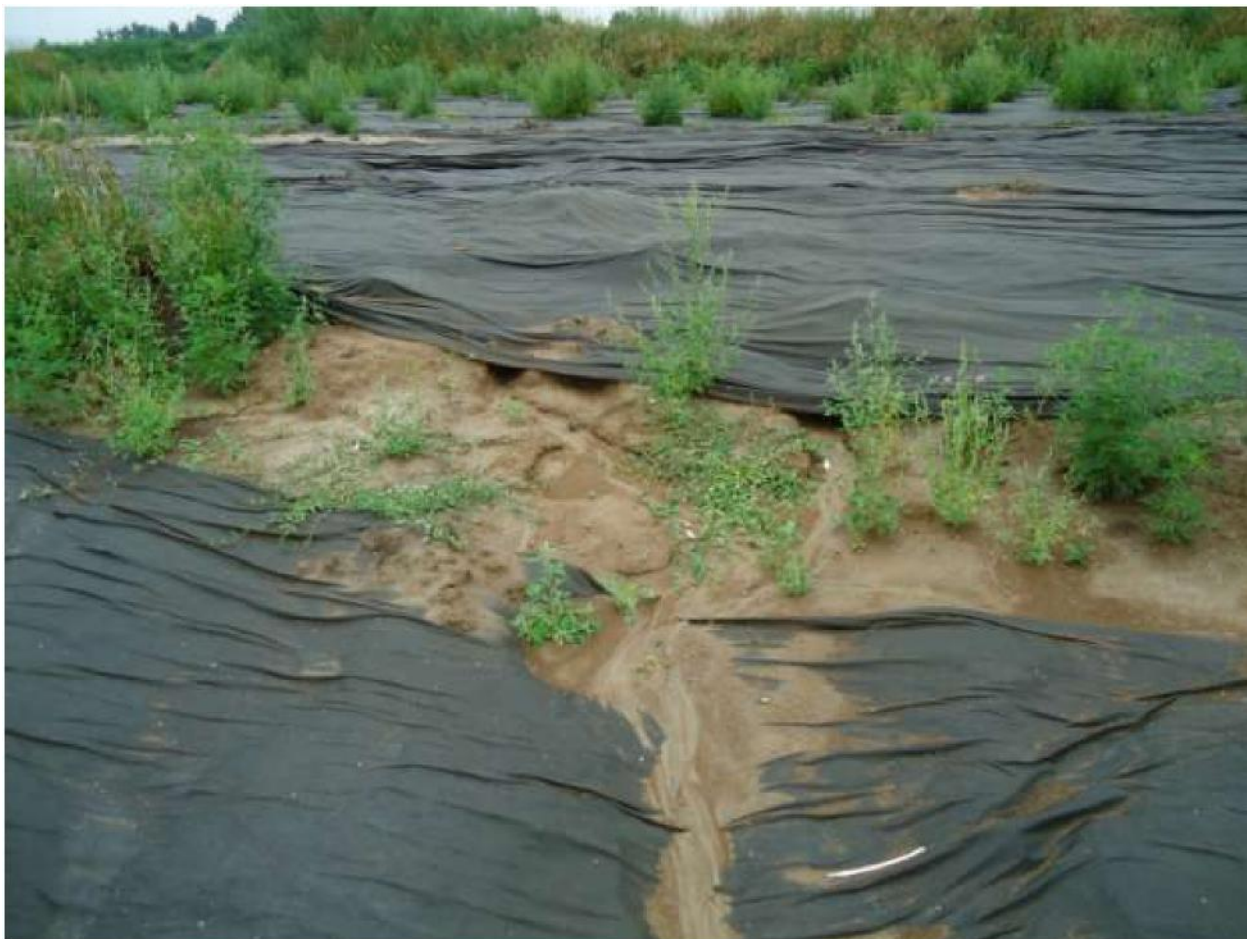
There has also been significant erosion on the site and the application of geotextile without covering soil or straw by MTC staff in the fall of 2010 has provided little protection from the effects of wintering, meltwater runoff and rainfall. The integrity of trench walls has not been protected with shoring and there is nothing to prevent soil stockpile erosion into the trenches. This situation was observed throughout the entire excavation area of the site, including the eastern palisade (*see Photo 6*).

Photo 6 - View to North of Erosion Under Geotextile, Displacement of Geotextile, and Subsoil Uplift Beneath Geotextile, August 03, 2011.

Note 2: Section 4.2.1 General Requirements for the Excavation of Archaeological Sites. Standards 10. In the case of partial excavation of an archaeological site, when the remainder is to be left intact through incorporation strategies, record any exposed faces, **shore up the faces to avoid collapse, and then backfill them.**

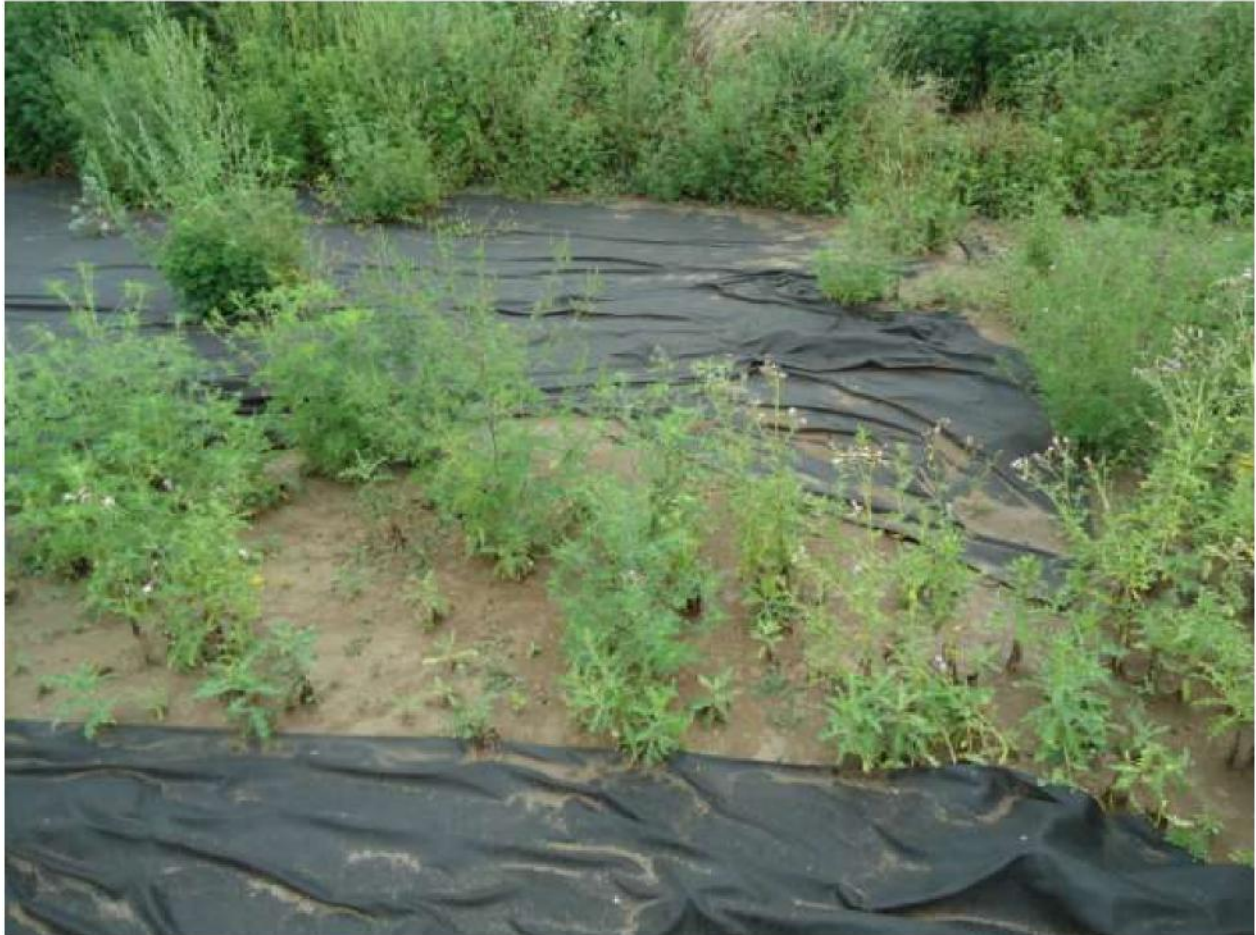
Photo 7 - View of Geotextile Displacement, Vegetation Growth in Unexcavated Subsoil Floor, and Minor Effects of Erosion. August 03, 2011.

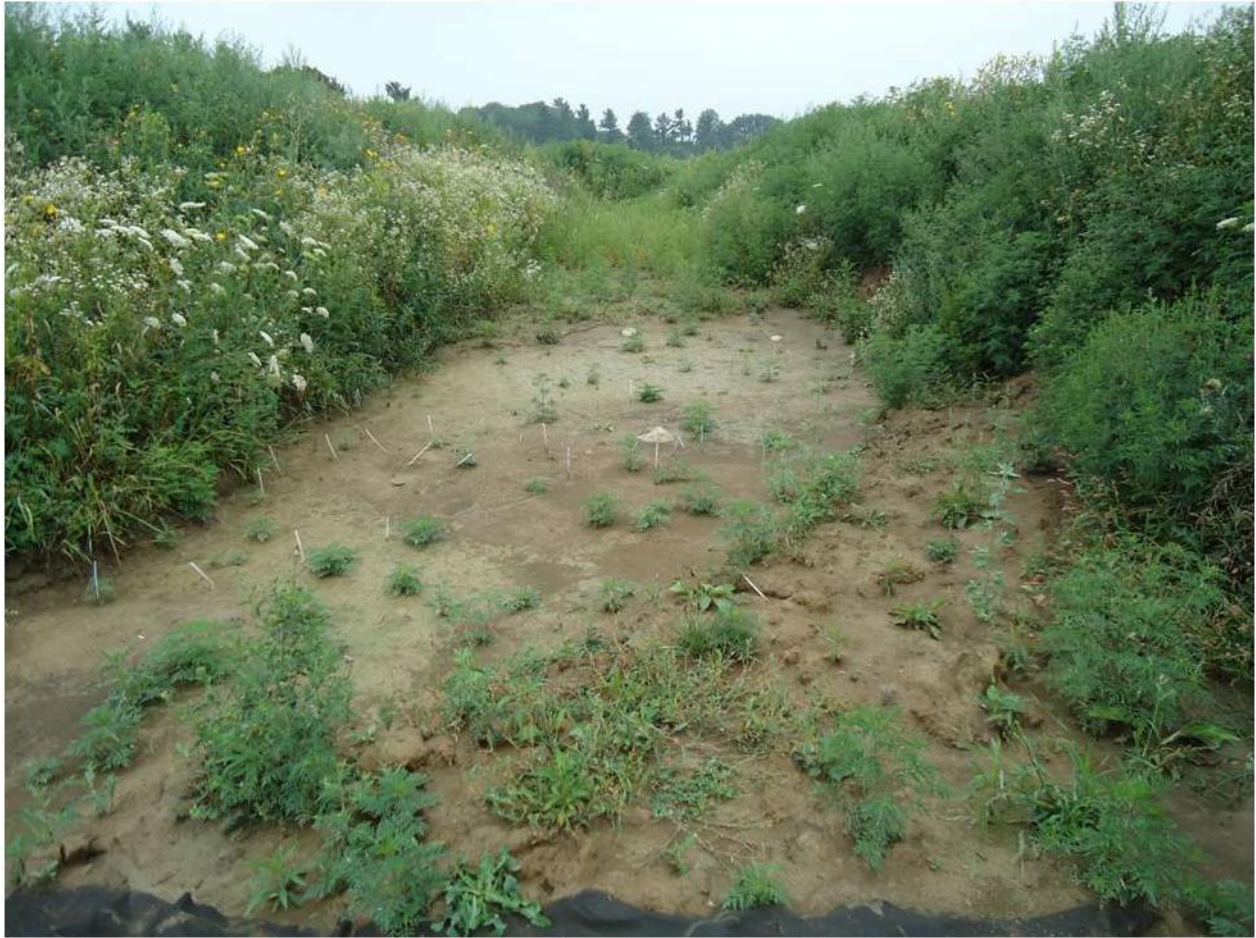
Substantial areas of the site are on hillslope and there has been both erosion and soil accumulation, depending on location. Topsoil stockpiles are eroding into the adjacent machine excavated trenches. In numerous locations the geotextile has been washed away from the underlying soil while other locations never had geotextile applied (*see Photo 7 and Standards Note 1*). The site is disappearing as time passes. No efforts have been made by MTC to restore the dislodged geotextile. We also observed areas where geotextile was absent, some being areas of recent work by MTC field crews with post molds marked with straws, and even the post molds and surrounding soil were substantially eroded (*see Photo 8*). .

Photo 8 . View West of Vegetated Trench Floor Not Covered by Geotextile (note MTC post markers in floor). August 03, 2011

Note 3: Section 4.2.3 Excavation by mechanical Topsoil Removal (Topsoil Stripping). Standards 4. Do not allow exposed subsoil surfaces to dry out such that cultural features can not be identified. **If there is a pause in the hand excavation, cover all mechanically stripped areas with tarpaulins and straw or soil.**

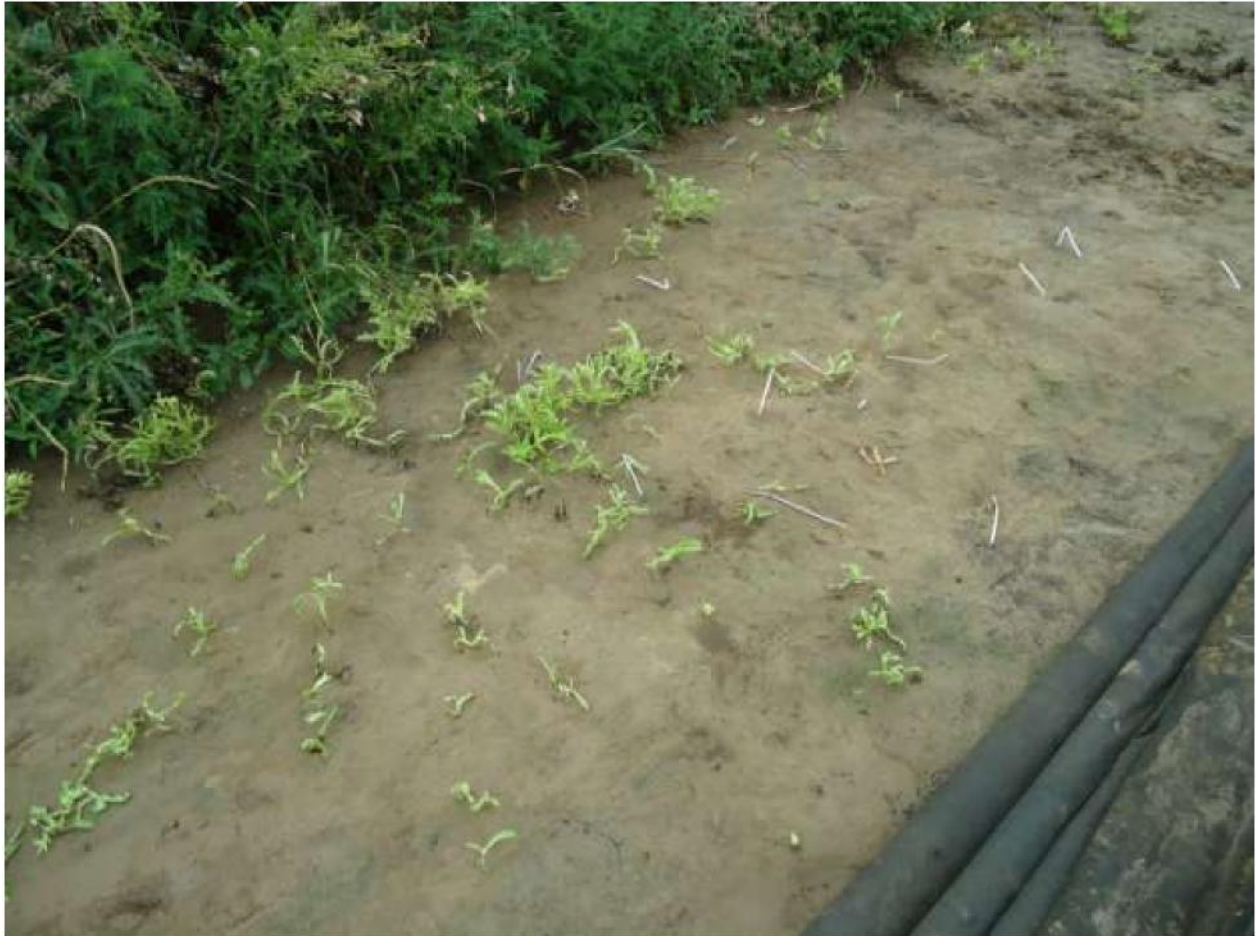
Vegetation effects on the site are substantial and may shortly verge on the catastrophic. Photo 9 shows new plant growth about to emerge through the geotextile from the subsoil. Photo 10 shows vegetation deeply rooted through the textile. This situation is present throughout the entire site area and on all geotextile covered areas. The integrity of the subsoil features, identified by 2010 excavation prior to the Stop Work Order, which are covered only by geotextile, is also disappearing rapidly. Erosion effects beneath

Photo 9 - Vegetation Growing Beneath Geotextile Seen When Geotextile Peeled Back. August 03, 2011.

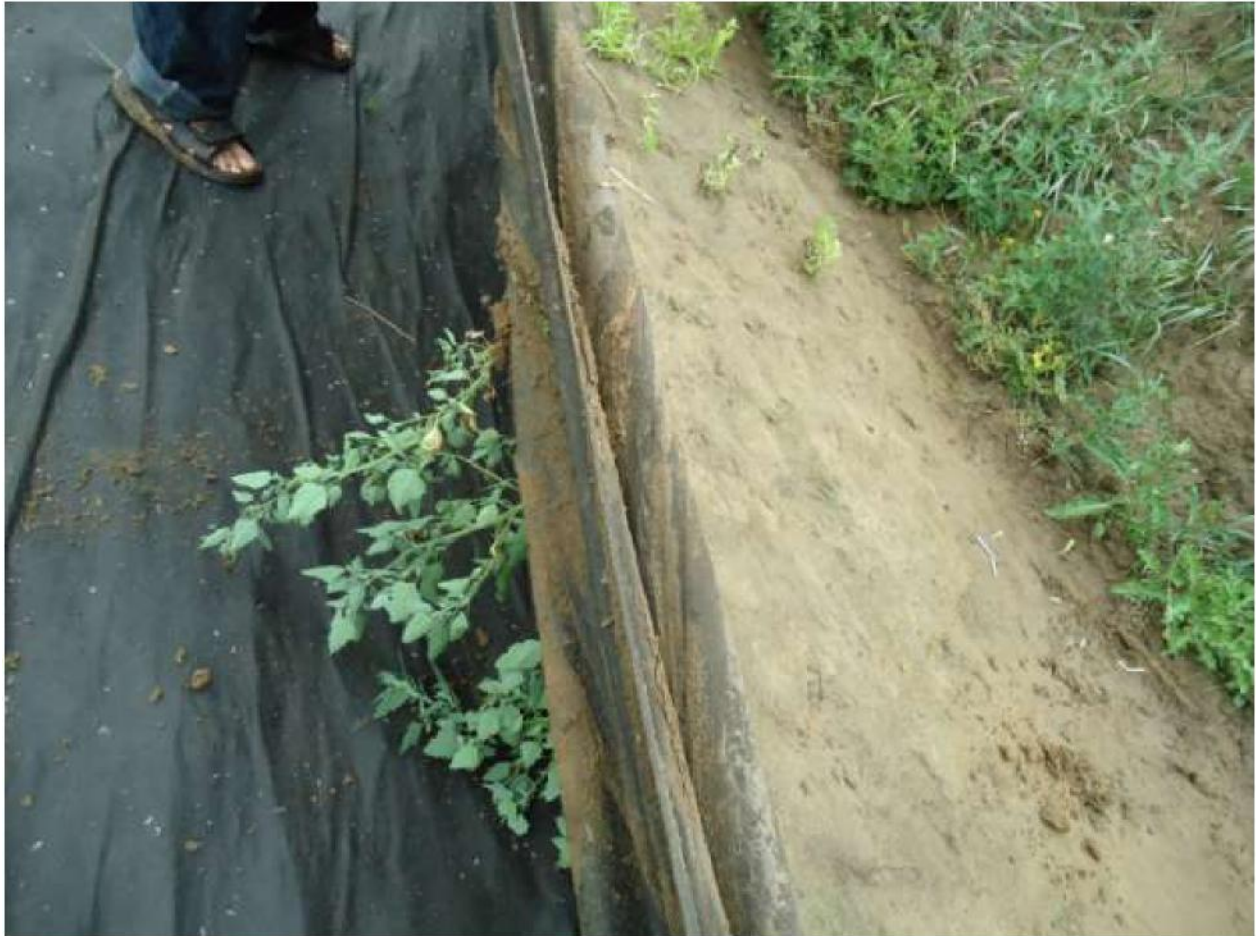
Photo 10 . Geotextile Peeled Back to Show Vegetation Growing Through Geotextile. August 03, 2011.

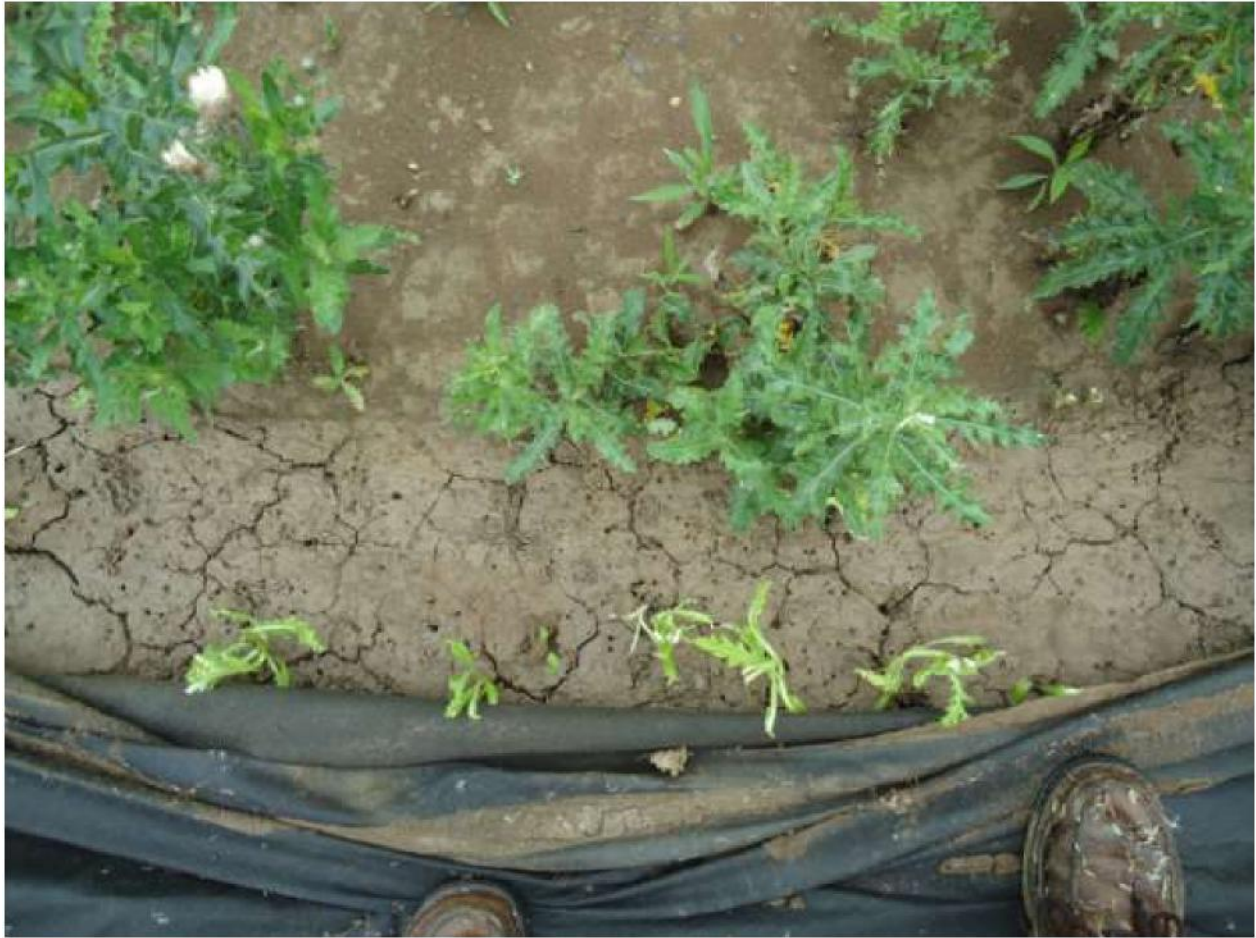
the geotextile have already been noted. Photo 11 also shows an example repeated in many areas where subsoil beneath the geotextile is dried out and cracked and new plant growth is damaging any features that may be present. Examples of frost-heaving beneath the geotextile were also noted.

Photo 11 . Geotextile Peeled Back to Show Soil Cracking and Vegetation Ready to Pop Through the Geotextile. August 03, 2011.

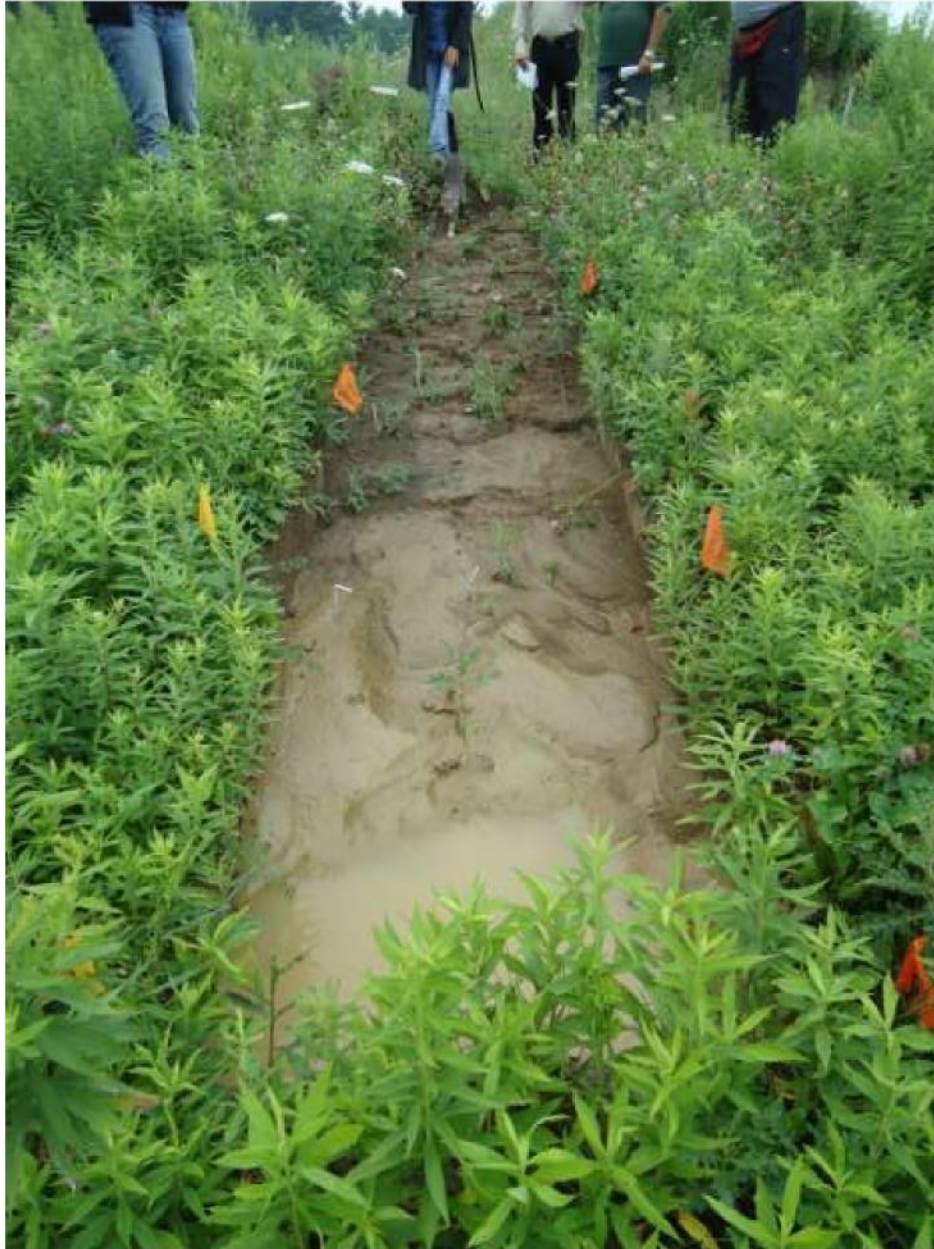
Between May 24 and June 11, 2011, an MTC field crew under the direction of Jim Sherratt (MTC) carried out Stage 3 field investigations of the eastern and northern palisade areas of the site. These excavations consisted of one meter trenches and a number of one meter units at intervals across the site designed to locate sections of the palisade. About two dozen of these Stage 3 units were observed during our visit on August 03, 2011. Despite the relatively brief time since MTC excavations concluded (June to August), there has been significant deterioration of these newly excavated areas through erosion and vegetation growth (see Photos 12 to 14). No protective measures have been taken with these newly excavated areas – there is no backfilling, no shoring of exposed trench walls to prevent collapse, and no geotextile (see Standards Notes 2 and 3). It is not known why MTC addressed the research issue of the palisade location while adequate protection of the site was ignored. Although MTC staff have until recently declined to discuss Skandatut with the APA, we do have a written assurance from Minister Chan that any archaeological field work carried out by MTC staff will conform to the 2011 Standards and Guidelines.

Photo 12 . 2011 MTC Trench Excavations in Area of Eastern Palisade Showing Erosion at Near End and Weed Growth at Far End. Units are not backfilled or shored up. August 03, 2011.

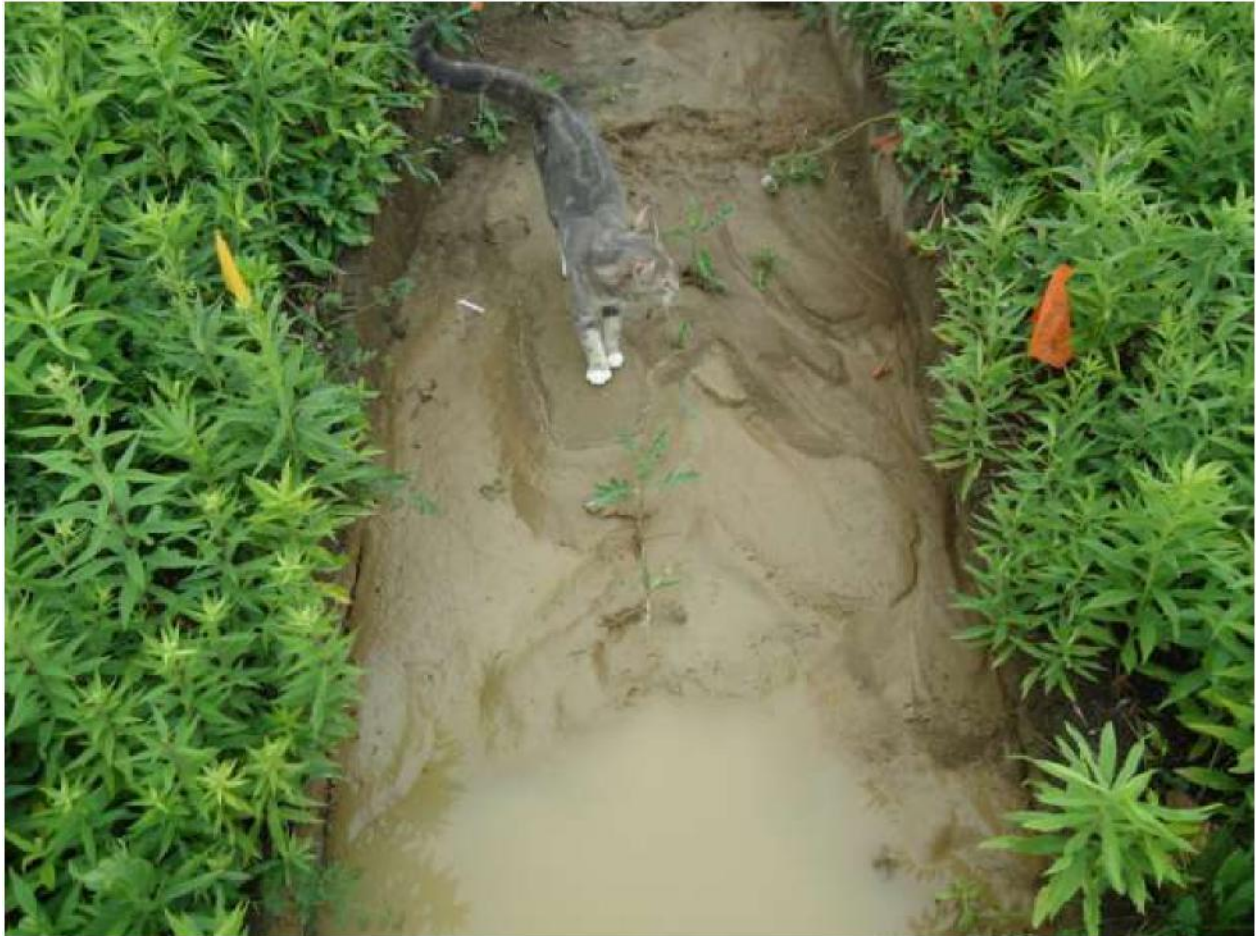
Photo 13 - Pandolfo Cat Stands on Thick Recent Soil Deposition in 2011 MTC Trench. August 03, 2011.

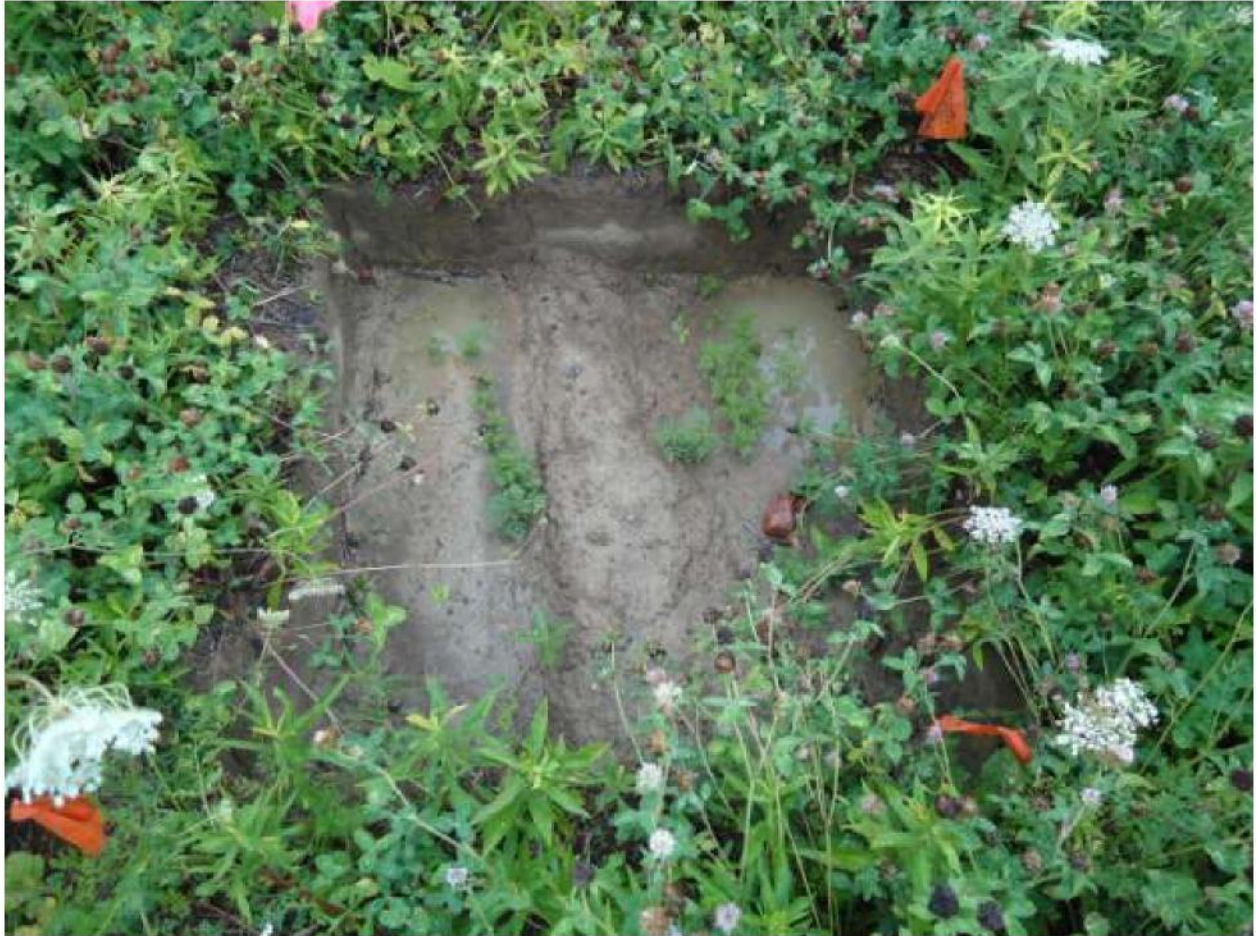
Photo 14 . 2011 MTC Stage 3 Meter Square Excavation in Area of Eastern Palisade. No Stage 3 units were backfilled or Shored Up. August 03, 2011.

Note 1: Section 3.3.2 Large Woodland Villages. Standards 6. If excavation of trenches uncovers a cultural feature, do not excavate into feature fill, Instead: a. record the exposed plan of the feature. b. **place geotextile over the unit floor and backfill the unit.**
